Re-Use Guidelines

Hangar 3 (Building No. 47) NASA Ames Research Center Moffett Field, California

August 30, 2006

Prepared by
PAGE & TURNBULL, INC.
San Francisco, California

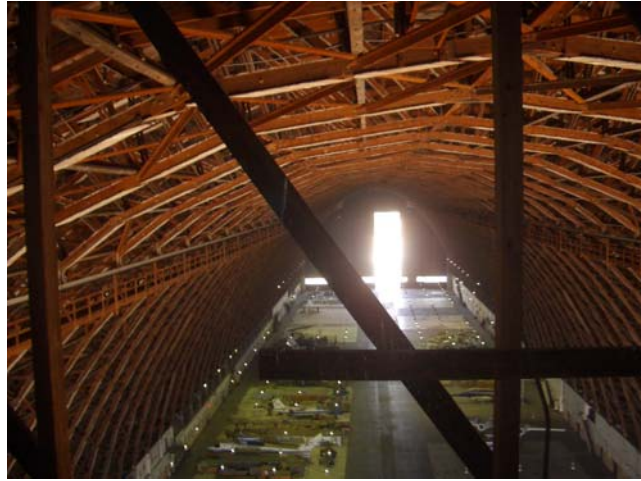
Figure 38. Upper arc of truss assembly, south end, Hangar 2 (Hangar 3 similar).

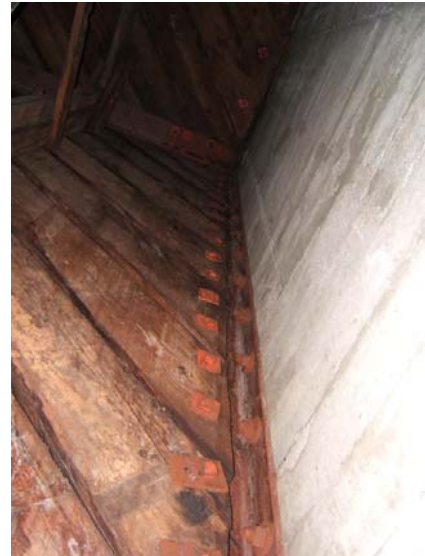
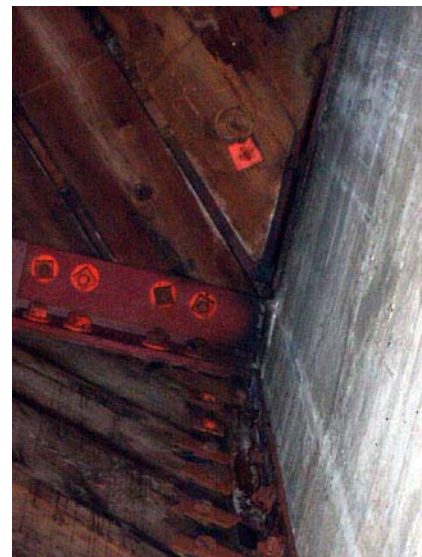
Figure 39. Angle iron union of box girder and corner tower, northeast corner interior corner Hangar 2 (Hangar 3 similar).

Figure 40. Detail of angle iron at juncture between box girder and corner tower, northeast interior corner Hangar 2 (Hangar 3 similar).

found on all the surfaces of the truss members inside the box girder. A steel angle iron connector unites the wood walls of the lintel to the interior concrete walls of the door towers and the steel and bolts are badly corroded, further suggesting the presence of water in the space (**Figures 39 & 40**).

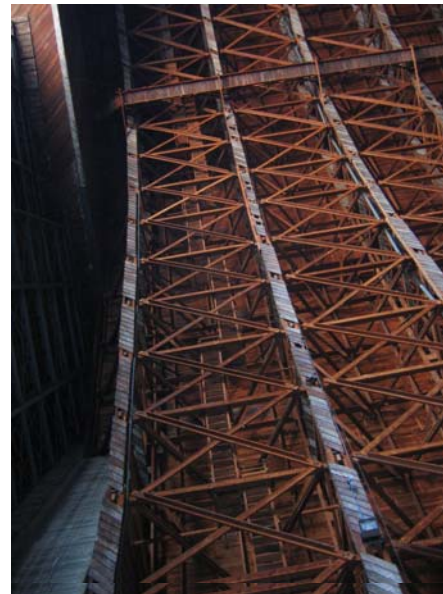
Within the truss system is a network of catwalks, ladders and railings that allow access to the upper regions of the hangar as well as movement between the trusses (**Figure 41**). All of these support systems are constructed from Douglas fir. These elements were not accessible for close inspection, so a condition rating was deduced. Based on the conditions observed in the trusses, the catwalks and ladders would be rated, at best, to be in Fair condition. Because of safety concerns, the ladders and catwalks were not accessible. It can be argued that they are no longer capable of performing their intended functions until a structural assessment proves otherwise. For more information on these systems, consult Section V of this document.

Figure 41 Braces, ladder and catwalk assembly between Bents #1 & #2, Hangar 2 (Hangar 3 similar).
